# BRE Test Report

## BRE Scotland Visitor Centre - Operational Performance Assessment – Window Blind Case Study

January 2017

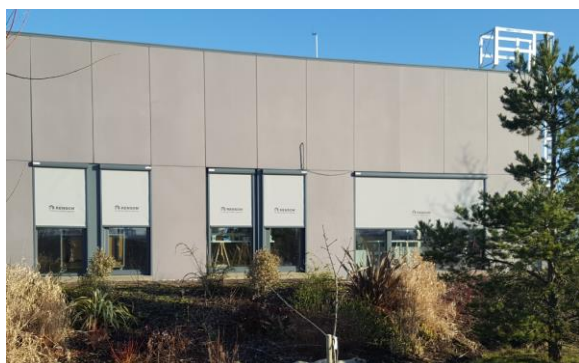
Figure 2: Renson external roller blinds installed on south façade

More recently, Renson external roller blinds have been installed to mitigate summer overheating problems. The installation is shown below in figure 2.

In 2016, Renson installed an external blind system to the windows on the south façade of the visitor centre in an attempt to mitigate the summer overheating.

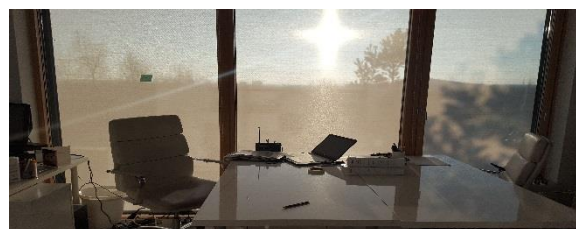
Figure 8: Internal space with blinds down

Another major advantage of the shading system installed at Ravenscraig is that, even when the blinds cover 100% of the glazed area, a level of natural light is still allowed to enter the building while removing any glare issues.
